Repairing Limestone Cladding

Corroding anchors and spalling limestone at the main Philadelphia store of Strawbridge and Clothier promoted a simple and cost effective repair program.

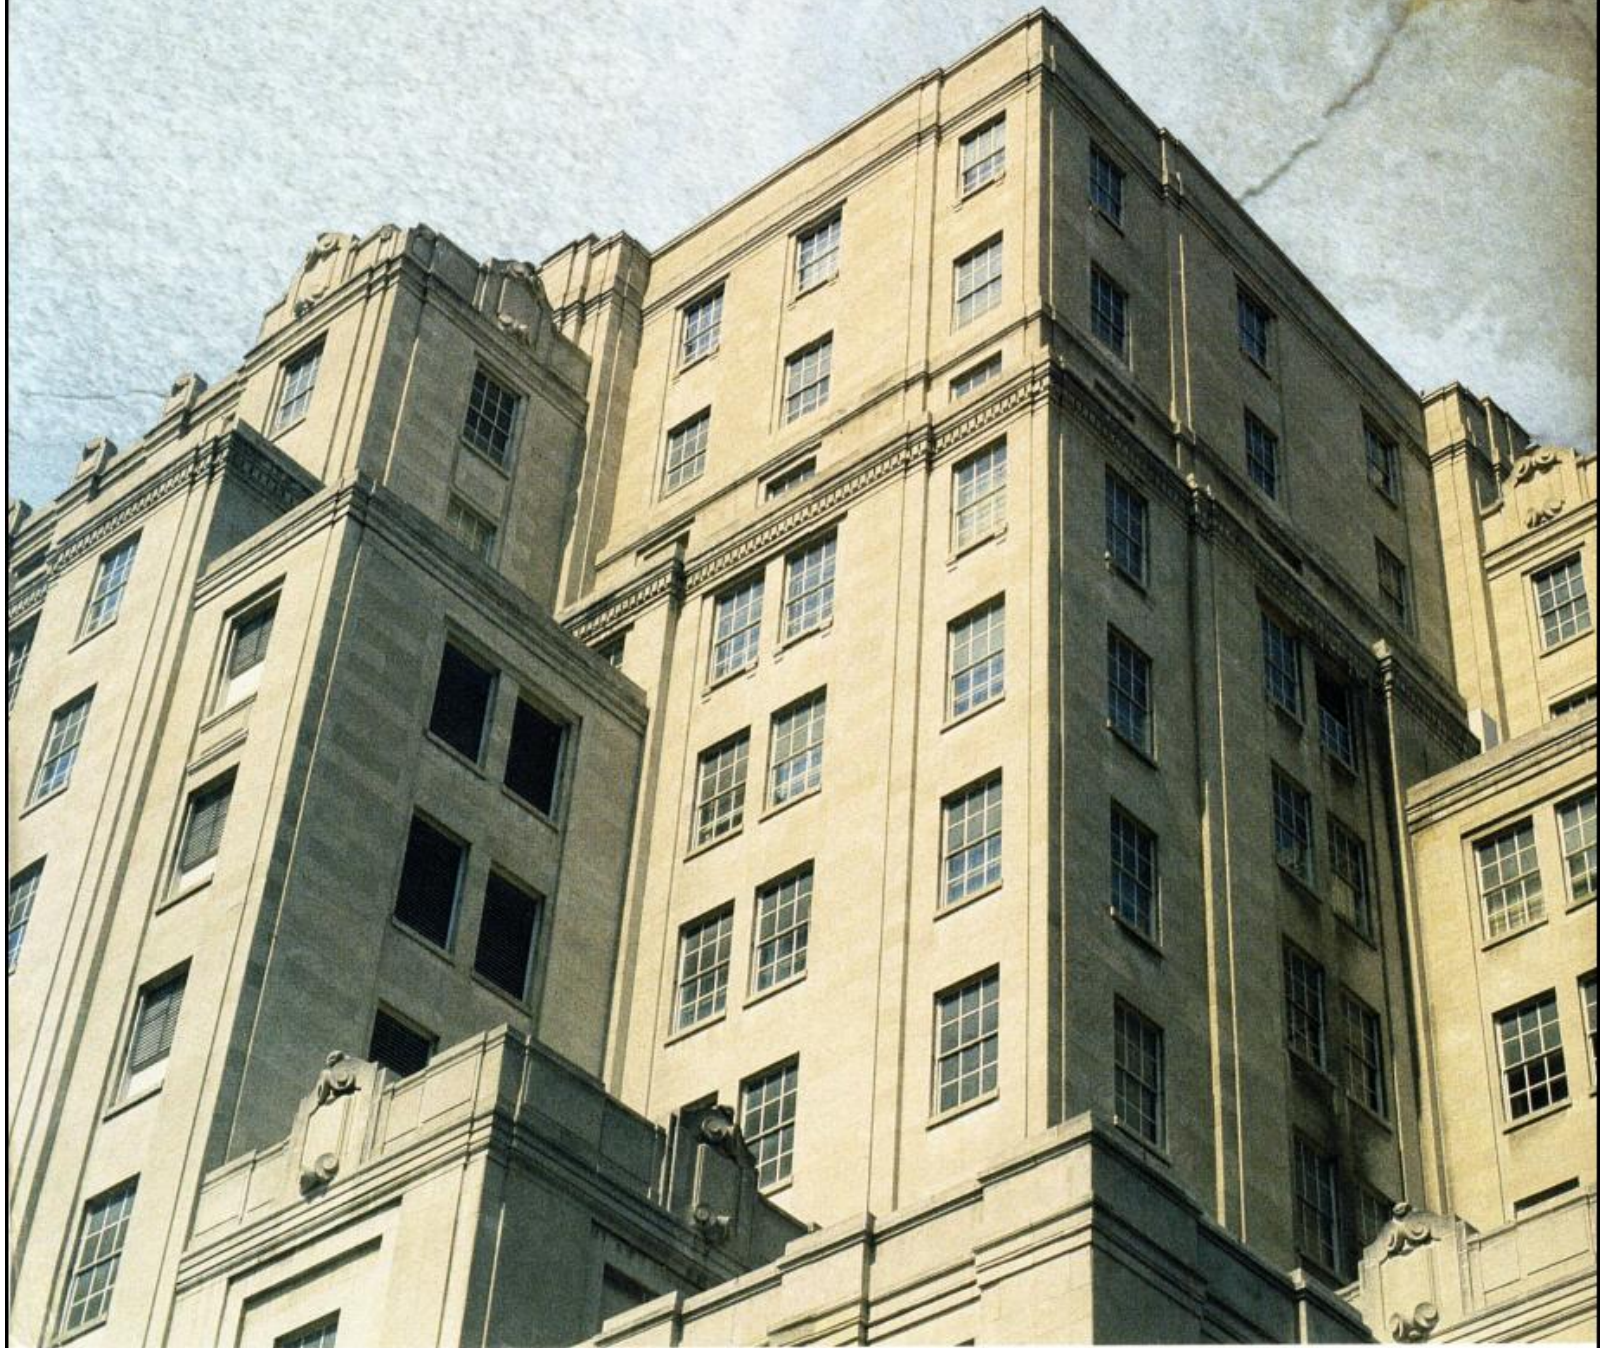
1 Overall view of Strawbridge and Clothier, Market Street East. 2 Overall axonometric view locating areas needing repair. 3 Detail of working drawings identifying spalls, patches, and spalling patches.

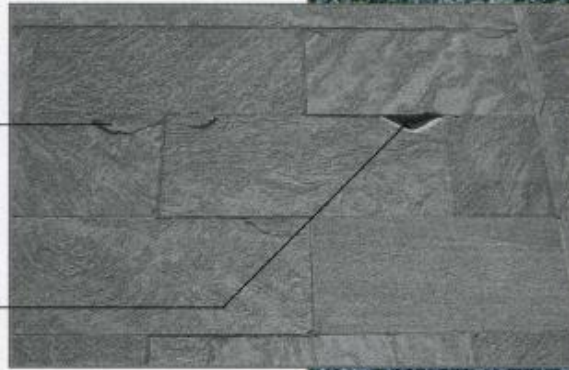
Although much of the spalled limestone was visible through binoculars from the street or adjacent rooftops, the steep viewing angle and unpredictable lighting conditions meant that as many as 10 to 20 percent of the problem areas are missed through this survey method.

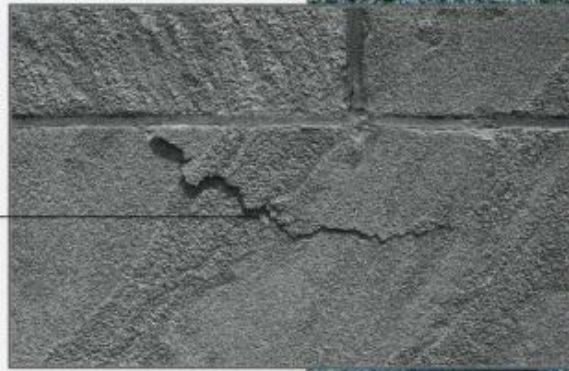
The spalled areas tended to be at the upper corners of the limestone blocks, where the original ferrous anchors were located. Highest priority was given to repairing those spalled areas directly above pedestrian areas or where falling stone could rebound onto pedestrian areas. About 1000 spalls were identified, of which 247 were considered priorities and patched during the first phase of the work.

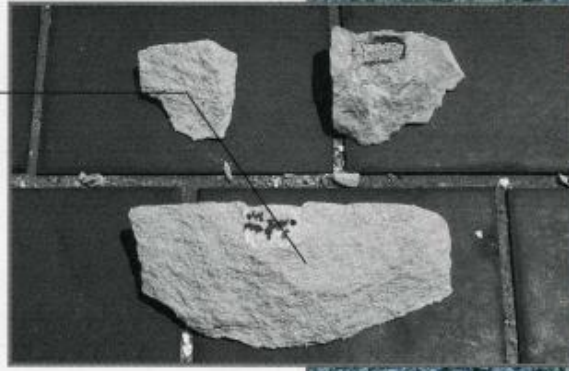
The spalling begins as a U-shaped crack caused by the internal pressure of rusting anchors, exposed to water through leaks in the stone joints, condensation on the inner face of the wall, and gaps in the roofing, flashing, and coping above. Once the crack occurs the exposure of the ferrous anchors to water accelerates the process until a piece of the stone pops off.

The spalled sections varied from small chips to large pieces 8" in diameter and over an inch deep. Each piece of limestone (or cement patch from previous repair efforts on the building) weighed between one and two pounds. Most of the chips were falling from the upper floors of the building, 10 to 13 stories above grade.

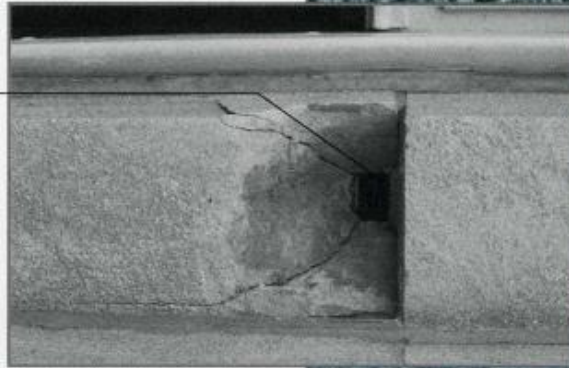
Once a section of stone had spalled off, the anchor was exposed to further corrosion, leading to additional cracking of the limestone. Repairs were necessary, not only to protect pedestrians from falling stone chips, but to stem the continued deterioration of the limestone wall.
